National Dam Safety Program. Cove Dam  
Number 1 (VA 06905), Frederick County,  
Virginia. Phase I Inspection Report.

PHASE I INSPECTION REPORT  
NATIONAL DAM SAFETY PROGRAM

NAME OF DAM: COVE NO. 1

Name of Dam: Cove No. 1  
State: Virginia  
County: Frederick  
Stream: Tributary to Laurel Run  
Date of Inspection: 16 June 1978

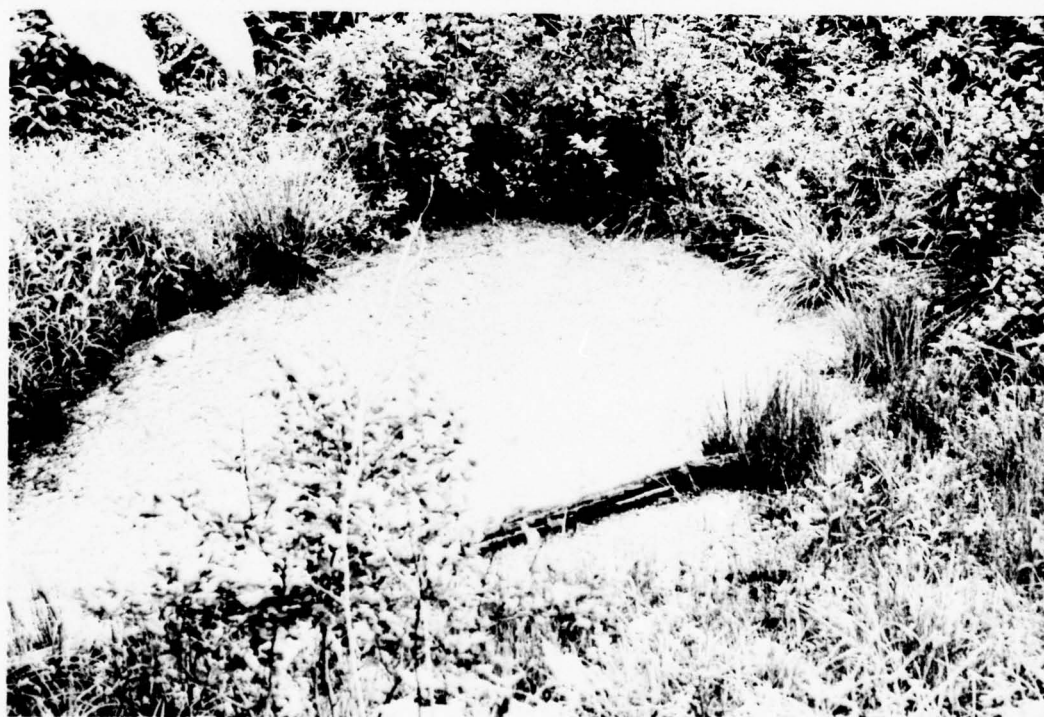
**PHOTO 2**

- 6.2.1 Visual Observations: No evidence of sloughing or sliding in the embankment, cut slopes or drainage structures was observed. Clear seepage occurs in three areas at the downstream toe of the dam. The seepage from a grouted outlet pipe has formed a small pond with a measured flow of 0.75 g.p.m. (see Photo 2).

**Small Red Pond at Covered Outlet of Sealed 10 Inch Pipe at Downstream Toe Near Middle of Dam**

ANY NOTICEABLE SEEPAGE	Seepage at the downstream toe 100 feet from the right abutment in a 50 feet wide area was not measurable. A 20 feet wide pond of red water (from iron precipitate) (see Photo 2) near the downstream center at the outlet of a 10 inch pipe which was reportedly grouted after it had been damaged. The pipe was not visible--covered with earth. A flow of 0.75 g.p.m. was measured. There is a wet area (100 feet long) from seepage on the left abutment of the embankment toe.	The seepage is of sufficient quantity to warrant close regular inspection and/or piezometers. A siphon drain is scheduled to be installed in the fall of 1978 to replace the 10 inch pipe, according to the owner.
STAFF GAGE AND RECORDER	None	
DRAINS	The owner reported that the downstream toe drain had been constructed by bulldozing scattered sandstone rocks into a pyramid section. There is a cover of soil and topsoil with a vegetative growth which obscures inspection of the rocks. Previously reported seepage occurs at the toe. The engineer's plans called for an embedded four inch tile drainpipe with porous backfill.	The toe drain presently seems to be adequate but the materials appear to be mixed.

- 4.4 Evaluation: The maintenance of the dam is poor with respect to the removal of trees and brush. However, the primary spillway pipe was free of debris and siltation (see Photo 4). The owner should immediately provide a means of draining the lake by repair of the existing, plugged, 10 inch drain or by new construction.

A detailed assessment of increasing spillway capacity and assessment of seepage conditions, including the clear seepage from the outlet pipe is needed immediately.

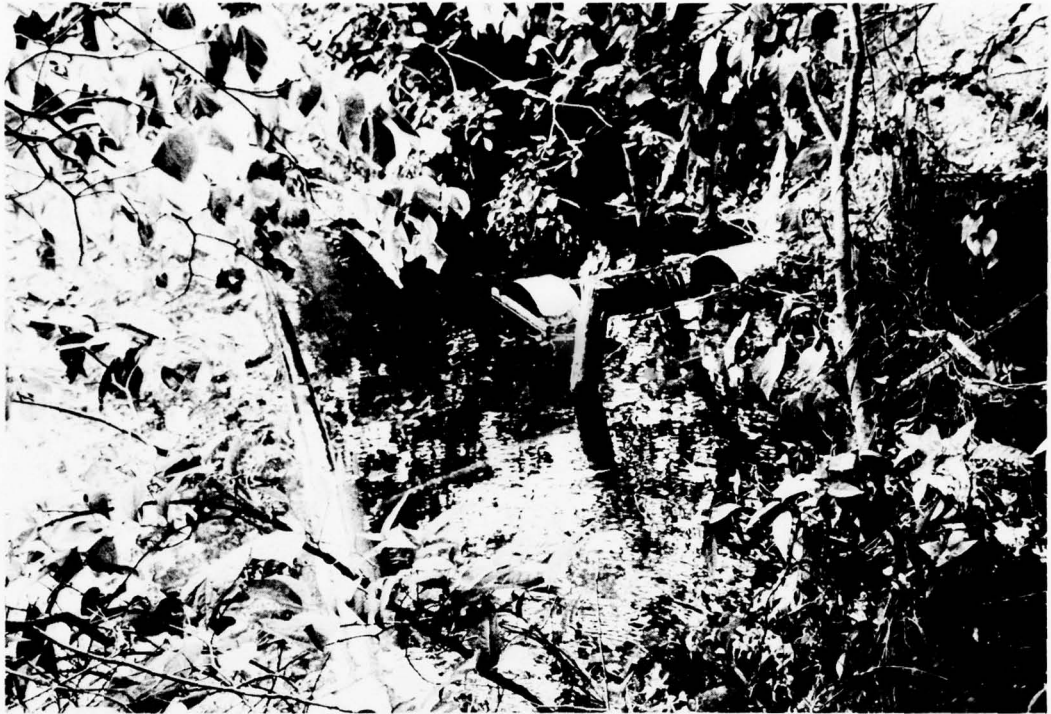
**PHOTO 3**

**Inlet of 24 Inch C. M. P. Principal Spillway Near Right Abutment**

VISUAL EXAMINATION OF	OBSERVATIONS	REMARKS OR RECOMMENDATIONS
CRACKING AND SPALLING OF CONCRETE SURFACES IN OUTLET CONDUIT	Not Applicable	
INTAKE STRUCTURE	The principal spillway is located near the right abutment (not as shown on the plans) (see Photo 3). The spillway is a 24 inch C.M.P. with a three feet notch to control the lake level.	
OUTLET STRUCTURE	The outlet structure is a 24 inch diameter corrugated metal pipe which empties into a stream bed with rocks and boulders on clayey and sandy silt. Trash has collected below the pipe in a roughly formed stilling basin which does not match the plans (see Photo 4).	The stilling basin should be enlarged and covered more evenly with rock. Deposited debris should be removed periodically.
OUTLET CHANNEL	The channel is uneven with a stream bed of rocks, boulders, cobbles and soil in a wooded area (see Photo 4).	The channel appears to be adequate for the existing flow, but should be graded to a uniform cross section.

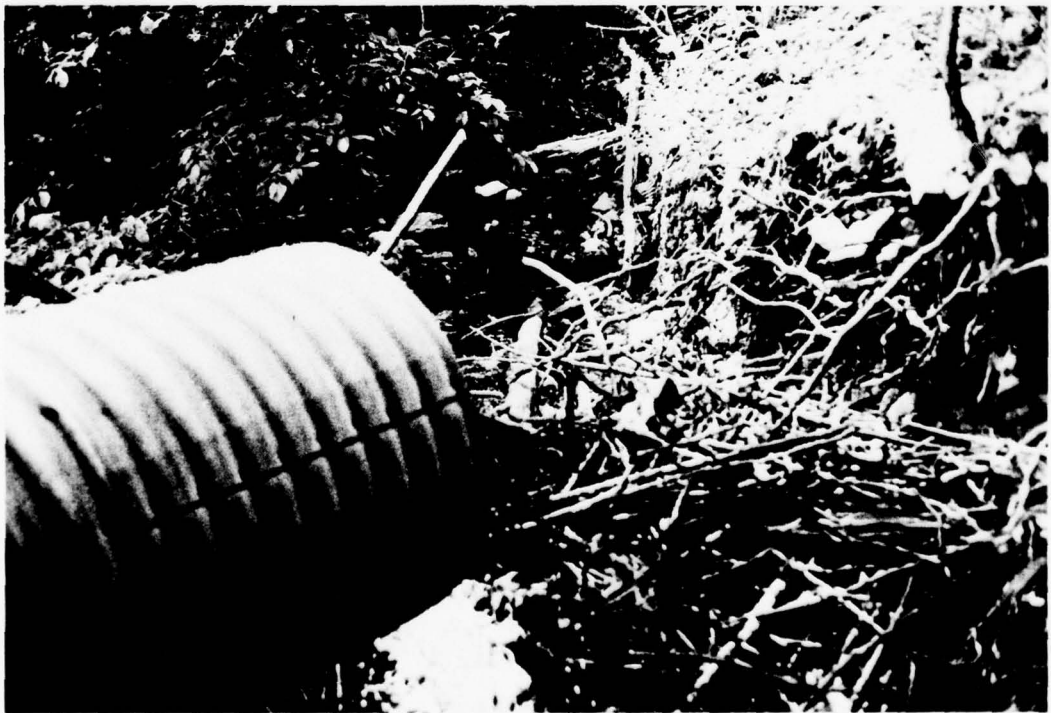
**PHOTO 4**

**Outlet of 24 Inch C. M. P. Principal Spillway Showing Stilling Basin With Trash and Downstream Channel**
